# CONSTRUCTION CASE STUDY TRAINING GUIDE

The Commission on Health and  
Safety and Workers' Compensation

CALIFORNIA DEPARTMENT OF INDUSTRIAL RELATIONS

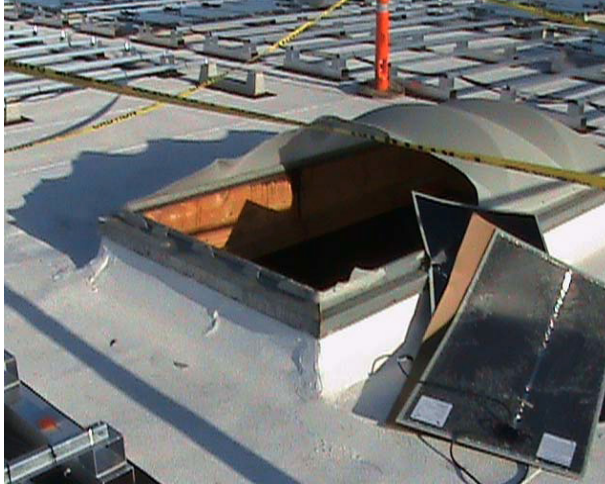
## Solar Panel Installer Dies from Fall

On the day of the incident, a worker and his co-worker were carrying and installing electrical solar panels on the roof of a warehouse. The roof contained skylights which were marked by the manufacturer as “tested in accordance with OSHA fall protection standards.” There are currently no uniform test criteria to determine material strength of skylights to withstand worker impact.

The solar panels were boxed and placed on the roof by a crane. Each panel was approximately two feet wide by four feet long and weighed 24 pounds. The worker and co-worker were carrying two panels at a time. As they approached a skylight, they had to maneuver around it with only 18 inches of clearance. The worker turned and walked backwards, tripping on the raised edge of the skylight. He landed on the skylight in a sitting position and then, without warning, fell through the plastic dome glazing. As the worker started to fall, the co-worker reached out and tried to grab his foot but was unable to reach him in time. The worker fell approximately 40 feet to the warehouse floor below. Numerous workers with radios immediately called the office to report the incident and those with cell phones immediately called 911. The paramedics and fire department responded within minutes. The worker was pronounced dead at the scene.

- The General Contractor assumed that fall protection was unnecessary.
- No fall protection methods were used.
- Workers were not trained in proper materials handling while working on a roof.

- Develop, implement and enforce a fall protection program to prevent falls through skylights. There are currently no uniform test criteria to determine the material strength of skylights to withstand worker impact. Such test criteria would include analysis of the degradation of plastic or plastic-containing materials after several years of sun exposure and the ability to withstand a point impact. One organization, ASTM International, is currently developing such testing guidelines. **At this time, employers should not assume that manufacturer testing ensures that a particular skylight can sustain the impact and weight of a worker. In order to prevent falls through skylights, employers should prepare, implement and maintain a fall protection program that includes:**

- Skylight screens capable of safely supporting 400 pounds or twice the weight of the workers plus equipment and materials (whichever is greater), or

- Guardrails around the skylight at least 45 inches in height with a top rail and mid rail which should be half way between the bottom surface and top rail. The rails should be able to withstand a live load of 20 pounds per square foot.

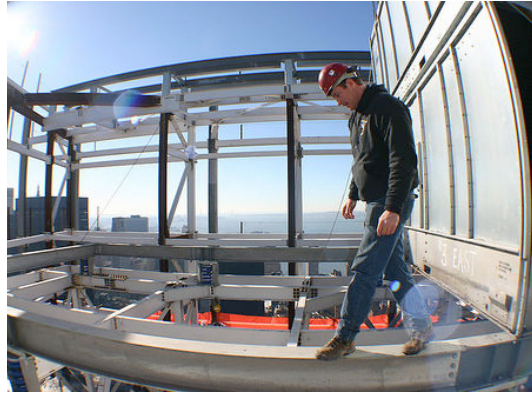
# Iron Worker Dies After Falling Off Beam

A 42-year-old structural iron worker foreman died when he fell 38 feet from a steel roof beam to the floor below while working on a warehouse that was under construction. The company was installing the final bar joist (structural steel beam) in the roof of a new cold storage warehouse. After a crane lifted the beam into place, it was not quite straight and the iron worker foreman wanted to use a beater (30# double sided hammer) to straighten it. The area where the foreman needed to work had been barricaded with wire rope safety lines on all four sides but he removed these lines to gain access. He was not using fall protection equipment. The foreman was standing on a portion of roof decking that had already been completed. To get to the beam, he reached his left foot out over an open un-decked area of the roof. He rested his left foot on the nearest joist girder. As he was preparing to strike a blow with the hammer, his foot slipped off the girder. His hands caught the bar joist but he couldn't hold on and fell.

- Require everyone working at heights to wear fall protection equipment and require that they are properly trained on how to use it.
- Make sure openings are properly covered or otherwise protected.
- If possible, provide alternate means of access to the work, such as an aerial lift (zoom boom).
- Provide Tailgate and/or other types of training on the proper way to install a bar joist.

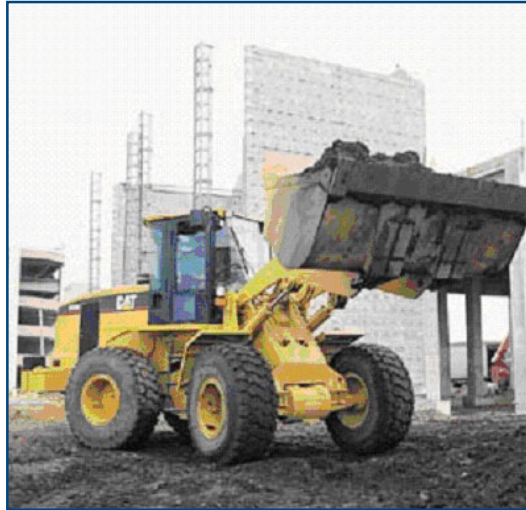
# Construction Laborer Run Over by Front-end Loader

A 19-year-old male construction laborer, performing the duties of a grade checker and directing traffic at a construction site, was inadvertently backed over by a front-end loader and killed. The worker had entered the moving equipment's immediate work area. The equipment operator lost sight of him. The front-end loader's backup alarm was not working at the time of the incident. The worker had never received formal comprehensive safety training. The company did not have a written code of safe practices that covered the hazards of working in close proximity to moving heavy equipment.

- Ensure that workers remain out of the immediate area where heavy equipment is operating.
- Ensure that when visual contact is lost with workers on foot, the equipment operator stops the heavy equipment and does not resume until visual contact is re-established.
- Ensure that the equipment being used has a working back-up alarm. (Equipment without a working back-up alarm should be removed.)
- Ensure that the IIPP includes a written code of safe practices on all hazards associated with the work being performed.
- Train workers to make eye contact with the operator before entering the work area. "If you can't see them-they can't see you."

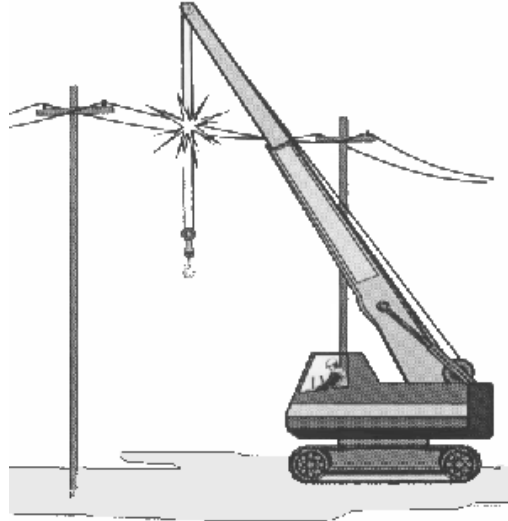
A 26-year-old construction laborer was electrocuted when he tripped and came into contact with an energized crane. The crane had become energized through accidental contact with a high-voltage line overhead.

The laborer's job on the day of the incident had been to assist the crane operator in lifting plywood to the second story of a residential structure. The crane was in an area with both telephone and high-voltage lines, and the crane operator was aware of them. Earlier in the day, the crane had brushed against telephone lines and had to be repositioned. However, at this time in the late afternoon, the operator's vision of the high-voltage lines was obstructed because of the sun's position. The main hoist line was being used to attempt the lift. In the process, the auxiliary line of the crane made contact with the high-voltage line. The auxiliary line burned in two and the ball/hook assembly fell to the ground. The voltage was 16,000 volts. The laborer was carrying a choker (wire rope) over to be used to attach a pile of plywood to the crane's hook. The crane operator and laborer were both startled by the fall of the ball/hook assembly. The boom of the crane momentarily drifted, contacting the high-voltage line directly. At the same moment, the laborer tripped and the choker he was holding brushed against the corner of the energized crane electrocuting the laborer.

- Working too close to high-voltage lines.
- There was no communication between the operator and the laborer.
- The crane operator's vision of the high-voltage line was blocked by the sun.
- The crane had become energized through accidental contact with a high-voltage line overhead. The auxiliary line burned in two and the ball/hook assembly crashed to the ground.
- The laborer tripped and the choker he was holding came into contact with the energized crane.
- No barricades were used around the work zone.
- No spotter on site to watch out for workers working around machinery and vehicles.

- Provide information to workers on what kinds of hazards to look for and how to avoid them.
- Develop and implement strict safety procedures when working with a crane in the vicinity of high-voltage power lines. Never operate a crane within 10 feet of high-voltage lines. Higher voltage may require greater clearances.
- Contact the local electric power company and have the power turned off when working within a certain distance of high-voltage power lines or have the lines insulated.
- Use barricades.
- Ensure that a spotter is present when working around energized power lines.

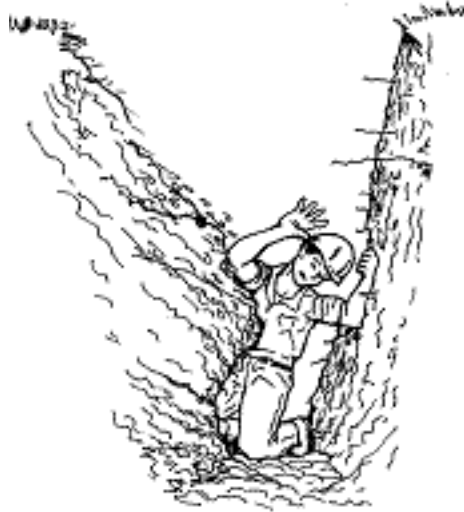
# Plumber Dies When Trench Collapses

A 35-year-old male plumber died when the trench he was working in caved in around him. The worker was in the trench connecting a residential sewer line to a sewer main when the incident occurred. The trench was seven feet deep and was not shored, benched or sloped. The area where the trench was located had been dug up before by other utilities. The soil that was removed from the trench was placed next to the edge of the trench. The company had shoring, but it was not available at this job site. The worker had been hired two days before the incident occurred and had not yet been to the company's orientation and safety training.

- Ensure that workers do not enter trenches deeper than five feet without the benefit of shoring, benching, sloping or shielding (unless it is in solid rock).
- Ensure that the excavated soil from a trench is a minimum of 2 feet away from the edge of a trench.
- Ensure that workers receive safety training before they are assigned hazardous work.
- Ensure that a competent person conducts inspections at the start of the work and as needed throughout the day.

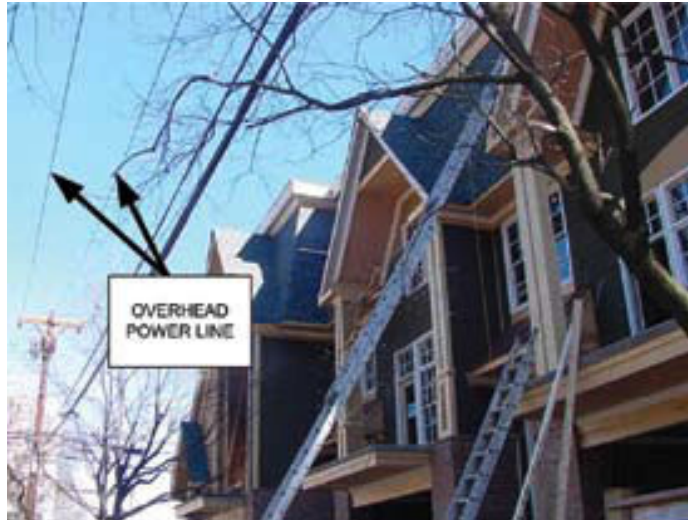
On a hot, humid day, a two-man weatherization crew arrived at a two-story home to blow cellulose insulation into the attic and then install roof vents. They were aware of overhead power lines in front of the home and planned the job with that danger in mind.

Because the home is attached to other structures on each side, the workers could only access the home from the front or rear. After inspecting the exterior of the house, the two men determined that the best way to enter the attic was to cut a hole in the roof. The men used an extension ladder to reach the roof. One worker, who wore sneakers, stood on the front sidewalk facing the center of the house and steadied the aluminum extension ladder by holding it upright with both of his hands at shoulder height and his feet on either side of the ladder. His partner, who was standing on the porch roof, used a rope to fully extend the ladder to 32 feet. He stood with his back to the house, facing his co-worker. As he pulled the rope, he looked up but did not see that the ladder had hit the wire and sparked. He heard his partner call his name and then saw him shaking. He pulled the rope to release the worker from the ladder and the electrical contact. According to the medical examiner, death was caused by electrocution.

- The workers were working too close to a power line and were using a metal ladder.
- The employer did not ensure that the subcontractor or workers implemented a hazard assessment plan.
- The employer did not ask the power company to de-energize the lines or request insulating sleeves.

- Safety hazards should be identified by the general contractor before the work takes place and in written instructions to the subcontractor; how to reduce exposure to the hazards should be addressed. The power company representative who inspects the house should look for electrical and other potential hazards in advance and inform the subcontractor about them.

- Make sure workers, their tools and building materials are a safe distance (at least 10 feet for most work) from high-voltage power lines.
- Have a third person as a spotter when workers are working close to power lines to watch for potential hazards.

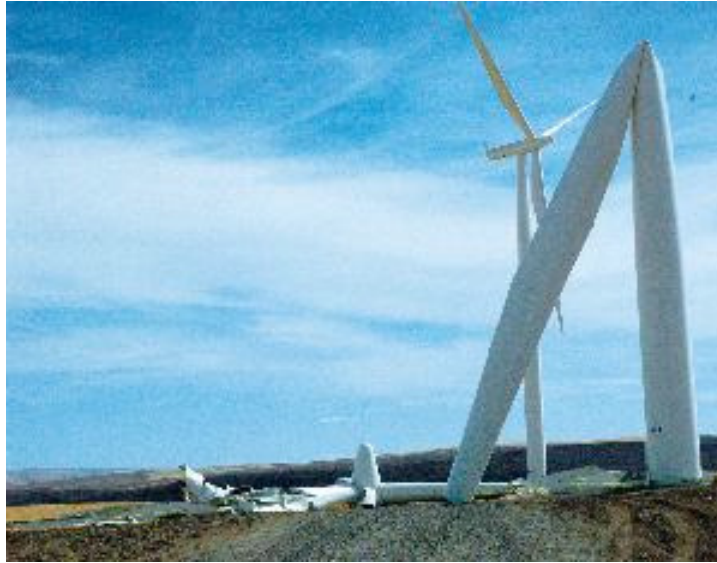
# Wind Turbine Tower Collapses Crushing Worker

In 2007, a man died at a wind farm under construction in Oregon in what is believed to be the first death of a worker from the collapse of a wind power tower in the United States. Three wind technicians were performing maintenance on a wind turbine tower. The technicians working on the turbine each had less than two months' experience and there was no supervisor on site.

After applying a service brake to stop the blades from moving, one of the workers entered the hub of the turbine. He then positioned all three blades to the maximum wind-resistance position and closed all three energy isolation devices on the blades. The devices are designed to control the mechanism that directs the blade pitch so that workers don't get injured while they are working in the hub.

Before leaving the confined space, the worker did not return the energy isolation devices to the operational position. As a result, when he released the service brake, an over speed condition caused one of the blades to strike the tower. The tower then buckled and collapsed, crushing and killing the worker. The second worker, who was on his way down a ladder inside the turbine, was injured. The third worker outside the tower was unharmed.

- The workers were not properly instructed and supervised in the safe operation of the machinery, tools, or equipment they were authorized to use. The workers were unaware of the potential for catastrophic turbine failure if the blades were not properly restored to their operational position.

- The company's procedures for controlling potentially hazardous energy during service or maintenance activities did not fully comply with OSHA regulations regarding developing, documenting, and applying lockout (LO) or tagout (TO) devices to secure hazardous energy in the "safe" or "off" position during service or maintenance. Several energy isolation devices in the towers (valves and lock pins) were not designed to hold a lockout device, and energy control procedures in place at the time of the incident did not include the application and removal of TO devices. The LO/TO plan should also include the proper steps to follow to put the equipment back into service.

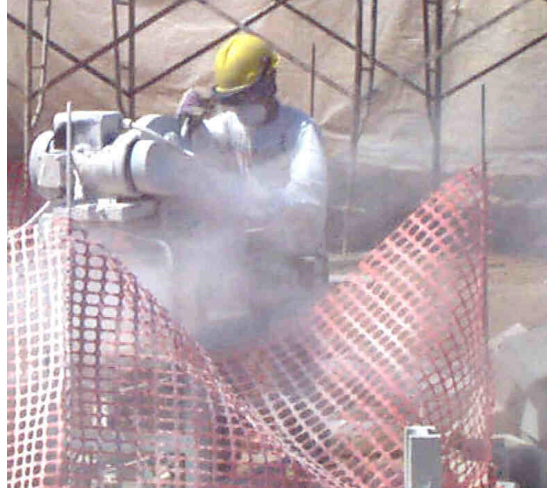
## Brick Mason Exposed to Silica Dust

A brick mason was removing deteriorating mortar from bricks in a building that was being renovated. To control the spread of dust, he was using a Vacuum Dust System that included a grinder shroud, a vacuum, a vacuum hose, and filters. His employer had also provided him with a respirator. The brick mason was not allowed to wet down the work area because his employer was worried about water damage to the interior of the building.

After several days of work, the brick mason started to develop wheezing and shortness of breath. He went to his physician who told him that his symptoms were most likely caused by the silica dust. He informed his employer who subsequently hired an outside firm to collect air samples of the work area. The samples contained about 200 times the NIOSH Recommended Exposure Limit (REL) for crystalline silica. The type of respirator the worker was wearing had an Assigned Protection Factor (APF) of 25, which provided protection from hazardous concentrations only up to 25 times the NIOSH REL.

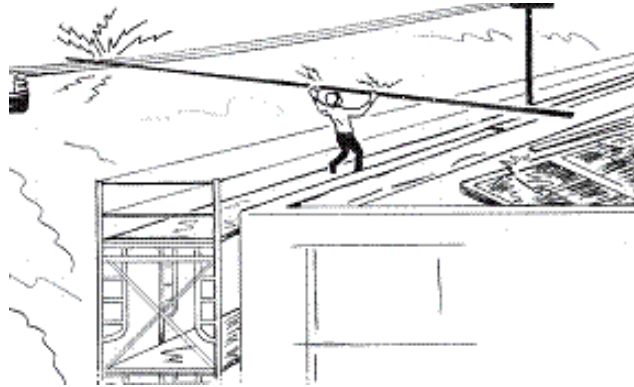
# Solar Technician Electrocuted From Contact with Overhead Power Line

A solar technician and two co-workers were installing a solar panel system on a building. Their supervisor had instructed them to strap a solar hot water tank to the roof using a 20-foot aluminum bracket. The crew tied rope around the bracket and climbed an existing scaffold at the rear of the building. The technician, positioned at the top of the scaffold, pulled the rope to raise the bracket. As he lifted the bracket to the top of the building, he turned it to a horizontal position. In the process, the bracket came in contact with high-voltage electrical lines that were 10 feet away from the scaffold. He was electrocuted and fell 35 feet to his death.

The Spanish-speaking technician had been in the United States for five years. For the past two years, he had worked off and on as a solar technician for a solar energy contractor. The contractor on this job had a safety program with written safety policies and instructions on how to work safely for most tasks, including lifting materials. However, not all of the policies and instructions were written in Spanish. There was also a solar training program that included either classroom instruction from solar equipment manufacturer representatives or on-the-job training from experienced solar technicians. The solar training covered some electrical hazards, but did not include hazard recognition and safe work procedures around high-voltage electrical lines.

- The material the worker was carrying was not at least 6 feet away from the high-voltage line; 10 feet is better.
- The contractor should have conducted a job site analysis before the work began to identify potential safety problems.
- The technician wasn't informed of potential job site hazards, like working near overhead power lines.
- Not all of the safety policies and information were provided in Spanish.

- Make sure workers, their tools and building materials are a safe distance (at least 10 feet for most work) from high-voltage power lines.
- Conduct a daily job hazard analysis of the work area, including any electrical hazards from high-voltage power lines.
- Establish and maintain safety programs that include electrical hazard recognition, including high-voltage power lines.
- Develop and implement strict safety procedures when working around high-voltage power lines.
- Contact the local electric power company and have the power turned off when working within a certain distance of high-voltage power lines or ask that insulating sleeves be used over the energized power lines.
- Translate all safety materials to Spanish and ensure that any new workers receive training on hazards, including how to work safely around high-voltage power lines.

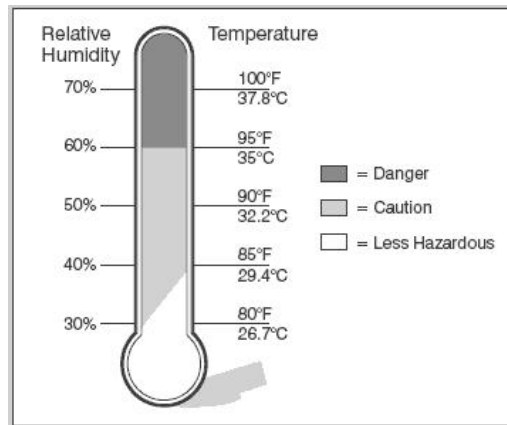
A certified welder had been hired by the construction company that day to work as a laborer sawing 2 x 4 boards in varying lengths to make wooden forms. He had only been on the job one day. Working in the direct sunlight, he wore a hard hat and tool pouch and used a hammer, a sledge hammer and a saw. He was dressed in heavy blue jeans, a tee-shirt and a long-sleeved heavy shirt. It was observed at lunch that the laborer did not eat, but did drink water. He worked until 5:00 pm, and was in the

parking lot on his way to his vehicle when he apparently collapsed beside his vehicle. Another worker found him on the ground and reported it to his supervisor. One of the first witnesses on the scene observed the laborer's heart beating through his shirt and his body jerking. The ambulance arrived and transported the laborer to a hospital where he was admitted with a temperature of 108 degrees Fahrenheit. He died at the hospital the next day due to heat stroke.

- A job that normally requires 16 people was done with 6 people. People were probably working quickly to get the job done. It's not clear if all the workers took all of their breaks during the day.
- The workers should have had extra rest breaks in hot conditions.
- Apparently there was no training on heat illness (i.e., symptoms of heat illness, acclimatization, proper hydration, proper clothing, shade, rest breaks, etc.).
- The new construction laborer did not have time to acclimatize to the heat. The amount of time he spent in the direct sun should have been reduced.

- Provide heat illness prevention training to supervisors and workers.
- Give workers frequent breaks in high heat to avoid dehydration and heat stress/stroke.
- Adjust work hours to accommodate environmental work conditions such as high heat and/or high humidity. When high temperatures are predicted, consider changing work hours to accommodate the weather. Instead of working in the heat of the day, work hours could be changed from 6:00 am to 2:30 pm, or at a time when heat and humidity exist at a lower level.
- Work hours for the laborer should have been adjusted to allow him to slowly acclimatize to the heat and humidity.
- Besides drinking plenty of fluids, workers should wear light colored clothing and fabrics that wick away moisture from the skin.
- Provide shade over the work area so the worker does not have to work in the direct sunlight.

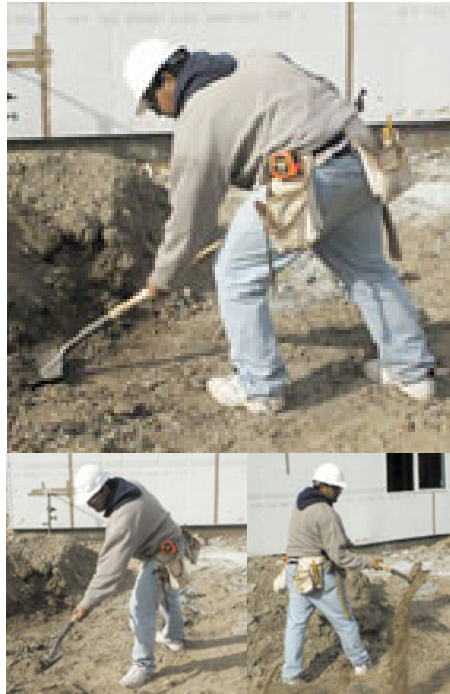
## Laborer Hurts Back

For the two weeks that a laborer had been on the job, he worked at digging a trench with a shovel every day. He had not received any training on ergonomics or proper lifting techniques, including proper body positioning while shoveling. After several days, he began to notice twitches and pain in his lower back. He didn't want to report it because he was a new hire and wanted to prove that he could do the work. At the end of the second week, he couldn't get out of bed one morning because of the pain in his lower back. When he stood up, he felt a shooting pain down his right leg.

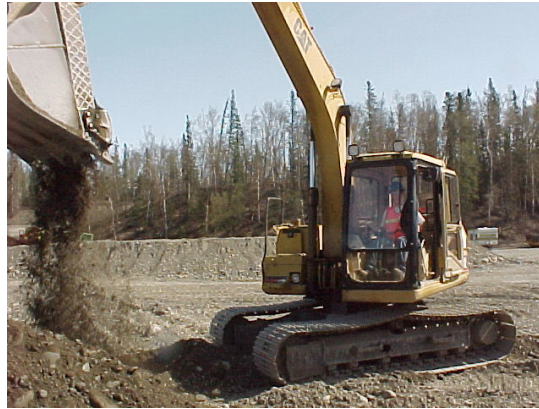
An operating engineer who operated heavy equipment for many years was having ringing/buzzing in his ears. He was also having problems understanding what people were saying if there was a lot of loud background noise, like at a noisy restaurant. His employers at various construction sites provided hearing protection for workers, but he didn't think he needed it because he was just operating equipment. He had never received any training about hearing loss or how to use hearing protection.

None of his employers provided hearing testing. His wife told him to go to a doctor to get his hearing checked. When he finally went, the doctor ordered audiometric testing. The engineer found out that he had significant hearing loss in his left ear and mild hearing loss in his right ear.

- Train workers on the dangers of exposure to noise and hearing loss.
- Provide training on the importance of using hearing protection and how to use it properly.
- Provide audiometric testing on an annual basis (not required in construction, but it is recommended).
- Use appropriate hearing protection.
